Steeling Home: The Rarest Kind of Pulmonary Hypertension

University Health Network, Toronto General Hospital and Mount Sinai Hospital,
University of Toronto, Ontario, Canada.

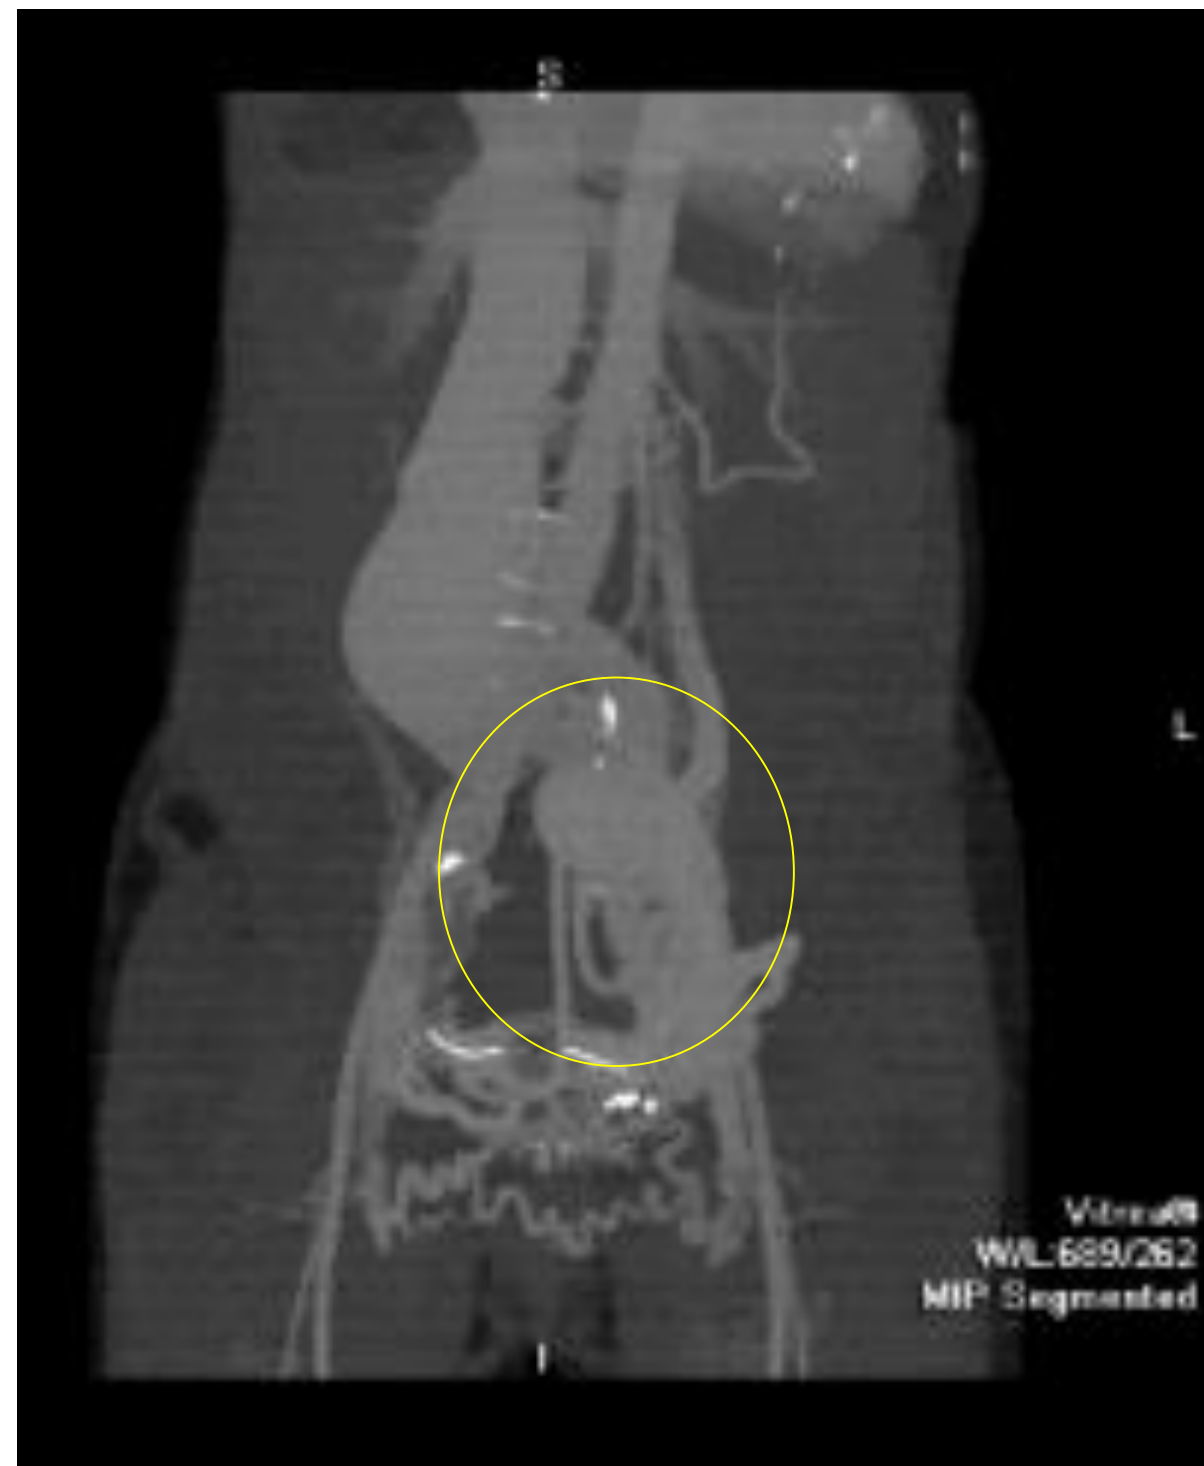
Figure 1.. CT angiogram showing massively dilated IVC and direct fistula between the left common iliac artery and vein.

Repeat right heart catheterization revealed a large pelvic arterial venous fistula and a markedly dilated IVC, which was the cause of the high output heart failure and likely pulmonary vascular remodeling responsible for the pre-transplant development of PAH.

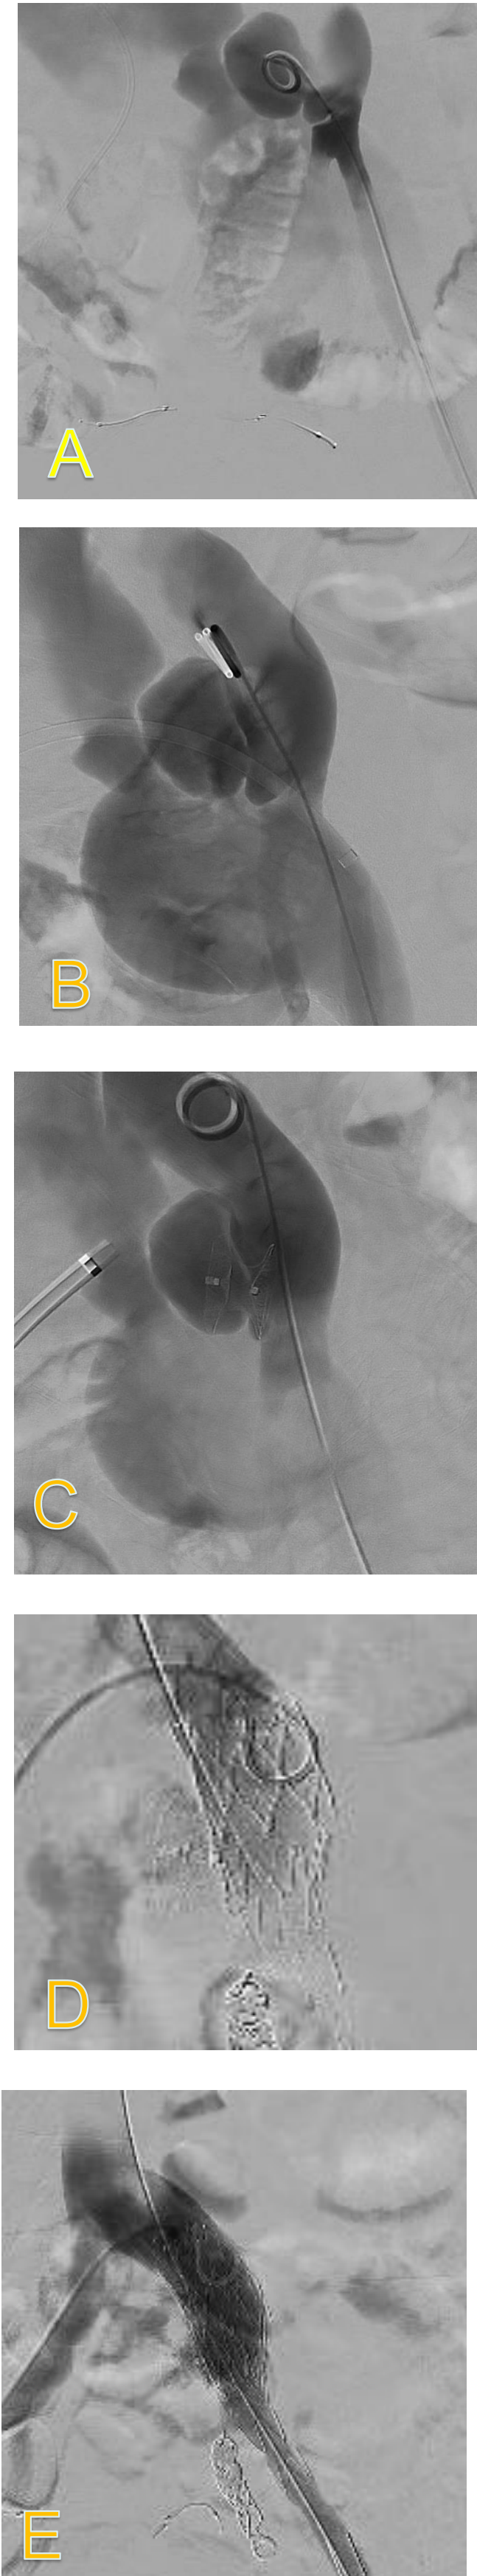
Figure 2. Panel A through E
Interventional procedure showing VSD closure device partial occluding of large left common iliac artery and vein (A-C). Subsequently treated with 3 overlapping covered stents (D-E).
